# **INDOOR AIR QUALITY ASSESSMENT**

**Lynch Elementary School  
19 Brantwood Road  
Winchester, Massachusetts**

Prepared by:  
Massachusetts Department of Public Health  
Bureau of Environmental Health Assessment  
July, 2000

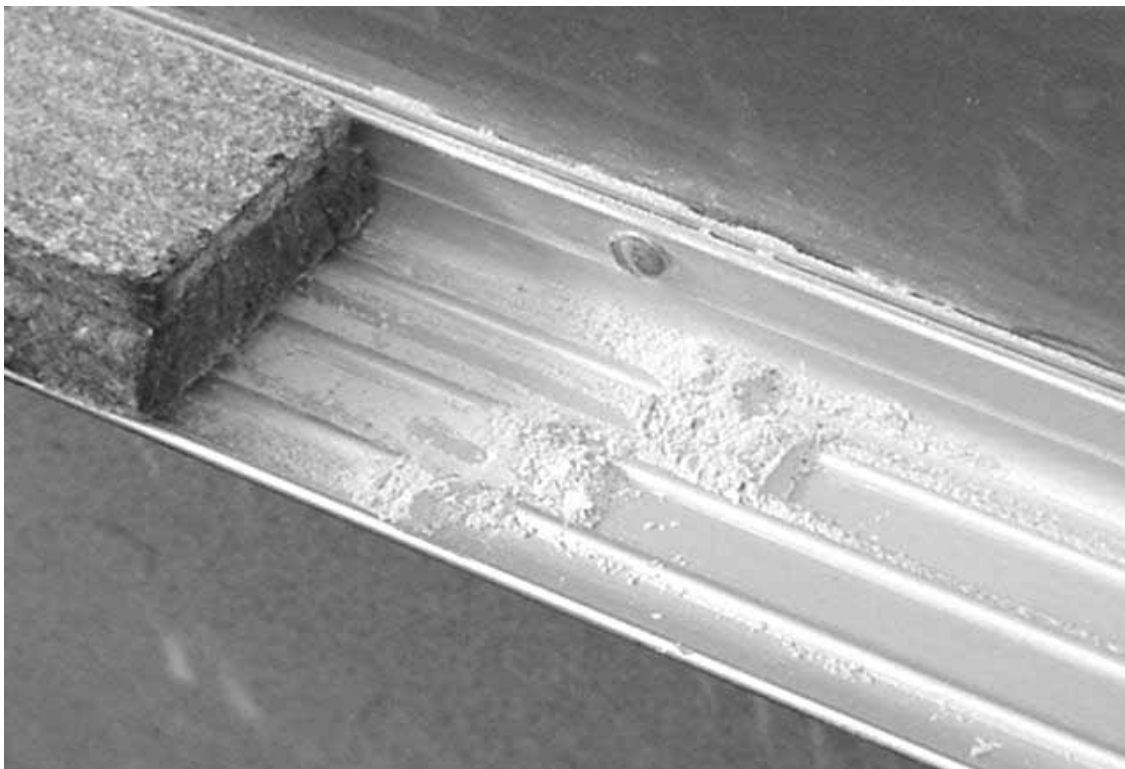
**Picture 24**

Accumulated chalk dust was noted in several classrooms (see Picture 24). Chalk dust is a fine particulate, which can be easily aerosolized and serve as an eye and respiratory irritant. Several classrooms contained dry erase boards and dry erase board markers. Materials such as dry erase markers and dry erase board cleaners may contain volatile organic compounds (VOCs), (e.g. methyl isobutyl ketone, n-butyl acetate and butyl-cellusolve) (Sanford, 1999), which can also be irritating to the eyes, nose and throat. Exposed fiberglass pipe insulation was noted in classroom 116 (see Picture 25). Airborne fiberglass particles can serve as a skin and respiratory irritant to sensitive individuals.

**Accumulated Chalk Dust Noted in Classroom**

17. Clean chalkboards and trays regularly to prevent the build-up of excessive chalk dust.
18. Encapsulate exposed pipe insulation to avoid the aerosolization of fiberglass fibers.

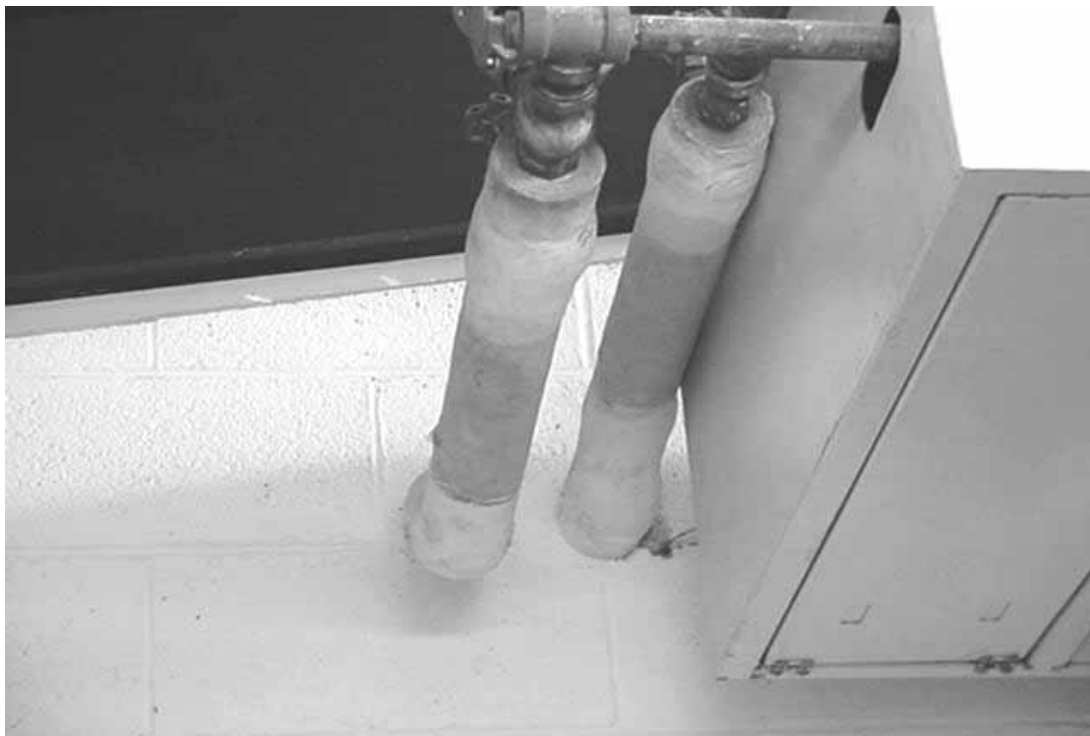
**Picture 25**

**Exposed Fiberglass Insulation**

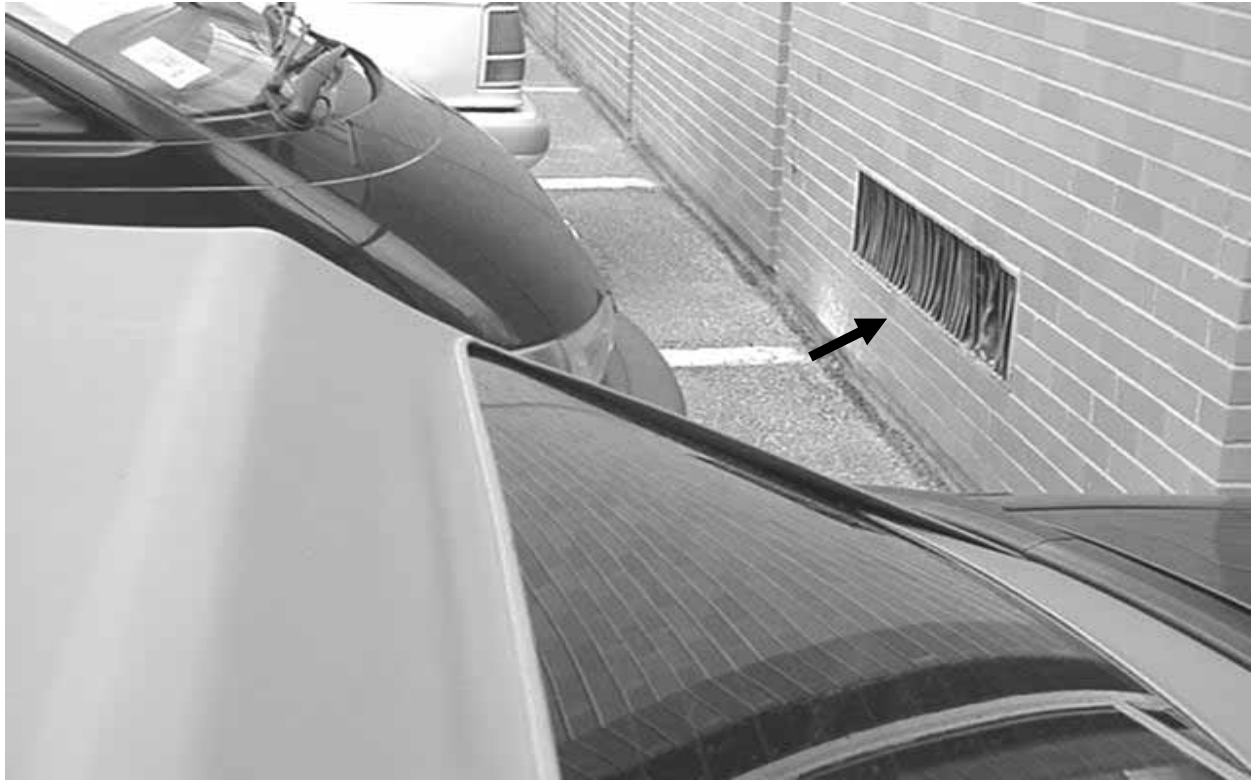
**Picture 26**

Although no complaints of vehicle exhaust odors have been reported within the building, the potential for entrainment exists. Picture 26 illustrates the close proximity of

the employee parking lot to the building and the potential for vehicle exhaust to be pulled into the univent fresh air intakes (called entrainment). Idling vehicles can result in the entrainment of vehicle exhaust into the building, which may, in turn, provide opportunities for exposure to compounds such as carbon monoxide. M.G.L. chapter 90 section 16A prohibits the unnecessary operation of the engine of a motor vehicle for a foreseeable time in excess of five minutes (MGL, 1996).

**Vehicles Parked in Close Proximity ( ~ 2-3 Feet) to Univent Fresh Air Intake**

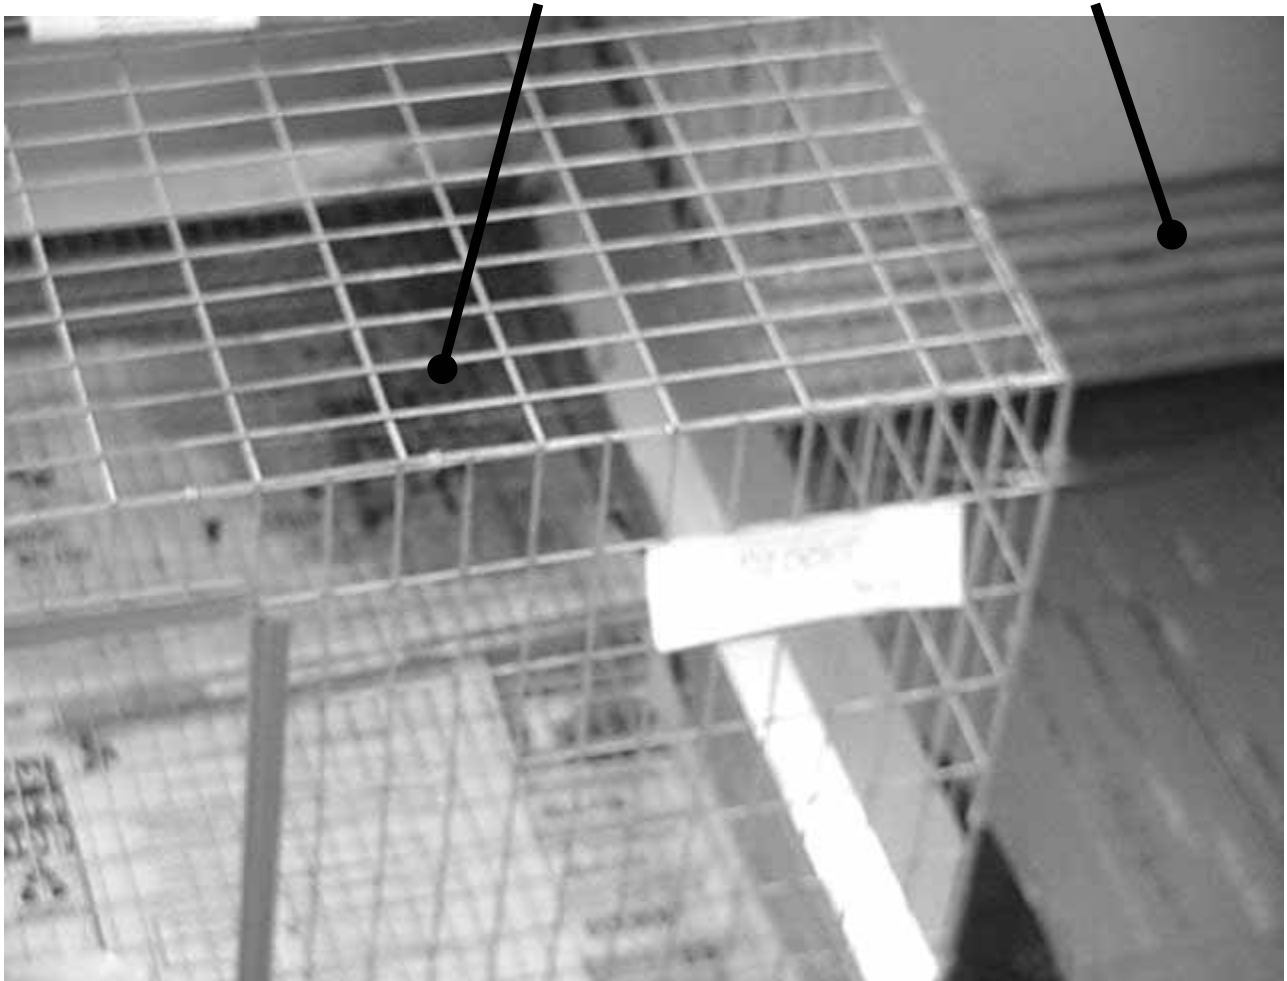
**Picture 27**

Classroom 102 contained a number of animals including, a rabbit, turtle, frogs and lizards. The rabbit cage contained newspapers, which were soiled with rabbit wastes, and was located in close proximity to the univent return vent (see Picture 27). Porous materials (i.e., newspaper) can absorb animal wastes and can be a reservoir for mold and bacterial growth. Animal dander, fur and wastes can all be sources of respiratory irritants. Animals and animal cages should be kept away from the air stream of ventilation components to avoid the aerosolization of allergenic materials and/or odors.

**Animal Cage in Close Proximity to Univent Return Vent  
Note Newspapers Soiled with Animal Wastes**
